WHITE PAPER

“Analysis of Mechanical Systems and Building Envelope of MOHAI Resource Center”

Historical Society of Seattle & King County dba Museum of History & Industry (MOHAI)

**Museum of History and Industry, Seattle, Washington
MOHAI Resource Center**

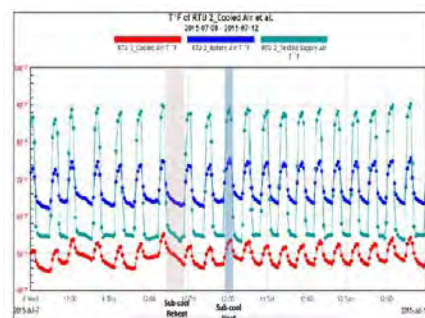
Figure 1: RTU 2 PEM Temperature chart demonstrates short-cycling July 7-12, 2015.

- **Key Learning 1: RTU 2 is short-cycling and conditioning inefficiently.** PEMS show that RTU 2 is locked in an inefficient cycle of alternating heating and cooling with the unit switching from sub-cool reheat to sub-cool heat mode, creating a conditioning band of 64-75°F. This cycle occurs at least five times a day (Figure 1).
- **Key Learning 2: Energy consumption is elevated.** A HOBO data logger installed on RTU 2 to determine

energy consumption showed a constant draw of 2.5 amps, indicating that even when the compressors and the condenser fans are not running, the supply fan still draws power. With short cycling, compressors run for 18 hours per day, drawing almost twice the energy when running two compressors. This shift from one to two compressors and back happens multiple times each day.

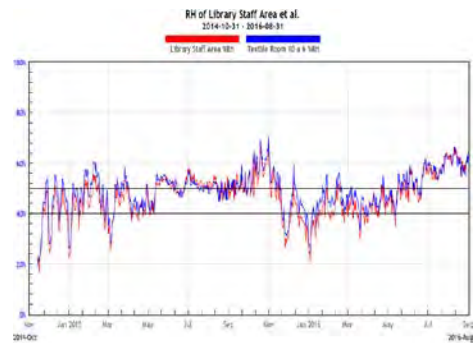
Figure 2: RH graph of library (red) and textile storage (blue) Oct 2014- Aug 2016.

PEMs indicate that the collections are most at risk for extreme fluctuations during shoulder seasons due to the unit's inefficiency. For example, in spring 2015, outside conditions at near-by Sea-Tac airport ranged from 28% to 90% RH, and in fall 2015, from 31% - 93% RH as recorded by the National Oceanic and Atmospheric Administration (NOAA). RTU 2 is unable to hold desired internal dew point due to the short cycling in the sub-cool reheat and sub-cool heating operation. As a result, library and textile areas experienced RH fluctuations between 28%-60% in spring (Figure 3) and 43%-67% in fall.

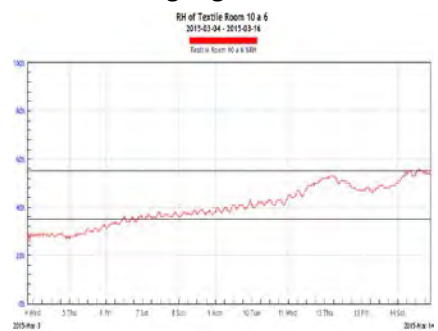
Figure 3: RH graph of textile storage March 4-16, 2015 indicates 29% fluctuation across 11 days.

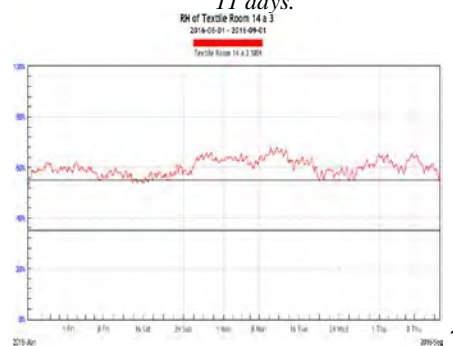
Figure 4: PEM RH graph of textile storage June-Sept 2016. Min RH 45%; Max RH 68%. Changes were not gradual enough to be considered seasonal drift.

Periods of sustained high humidity, as seen at right from June-Sep. 2016 also endanger the collections (Figure 4). RH higher than 55% creates a corrosion risk for metals and metal elements, and over 60% creates the potential for mechanical damage in vulnerable materials as well as risk for mold growth. After replacing a cooling coil in RTU 2 in Aug. 2015, and adjusting unit controls, Preservation Environment Evaluation metrics did improve overall. Yet, even with these changes, the supply air is not sub-cooled enough to remove enough moisture from the mixed air (recirculated air with a low percentage of incoming outside air). Consultants believe this is a mechanical limitation of RTU 2.

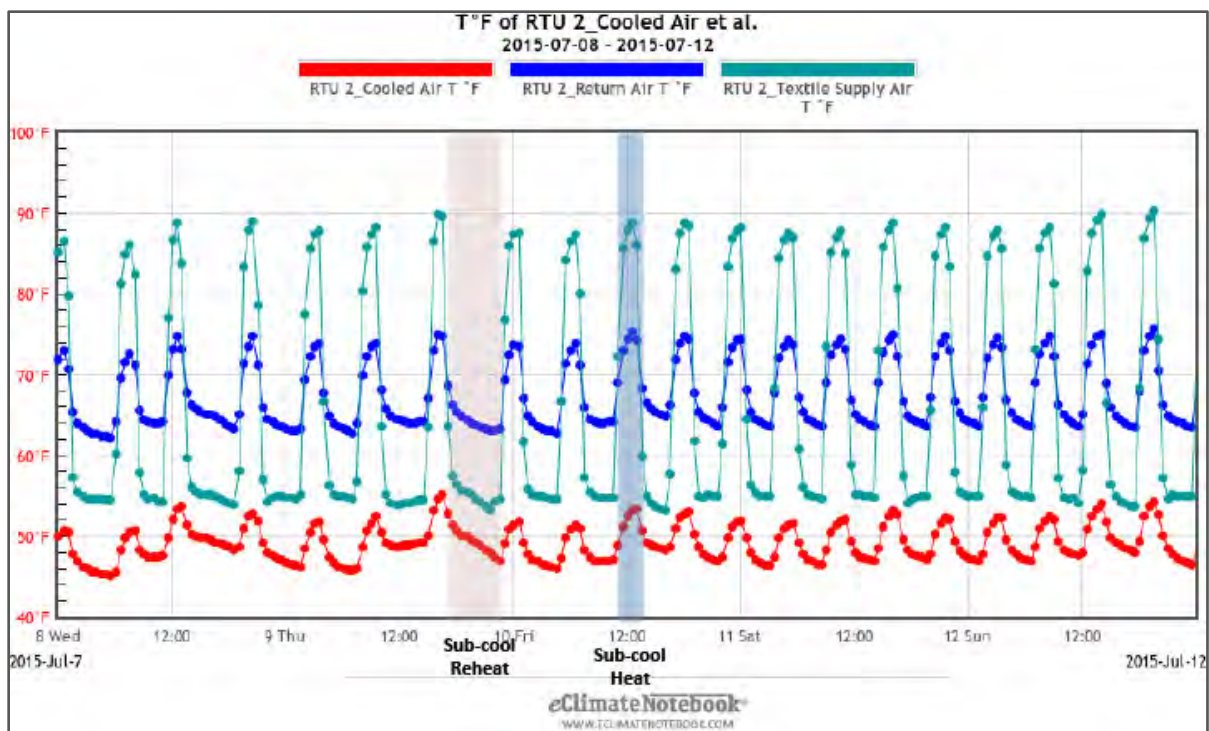
Based on available data, it is evident that the unit is almost always cooling to some degree. The unit appears to be fighting itself, creating a continuous loop by switching from sub-cooling reheat to sub-cooling with heating constantly. Using one loop as an example, it was noted that the unit operated in sub-cooling reheat mode until a temperature of 65°F was reached. At this point the unit switches into sub-cooling with heating mode for nearly two hours, warming the air until the space reaches 75°F. When the temperature reaches 75°F the unit switches from heating mode back into sub-cooling reheat mode. It is not clear whether it is the return air sensor or the room thermostat that controls the heating mode. This is causing an almost endless cycle of alternating heating and cooling with the unit switching from sub-cool reheat to sub-cool heat mode, creating a conditioned band of 64-74°F. This cycle occurs at least five times a day, and can be seen in both eClimateNotebook and power consumption graphs. The graph below illustrates this behavior over four days in July 2015.

- Current Performance: There are a few issues with the unit. First, the unit is alternating between sub-cool heating and sub-cool reheat multiple times during the day. Second, the unit appears to switch into sensible cooling mode when it does not need to.

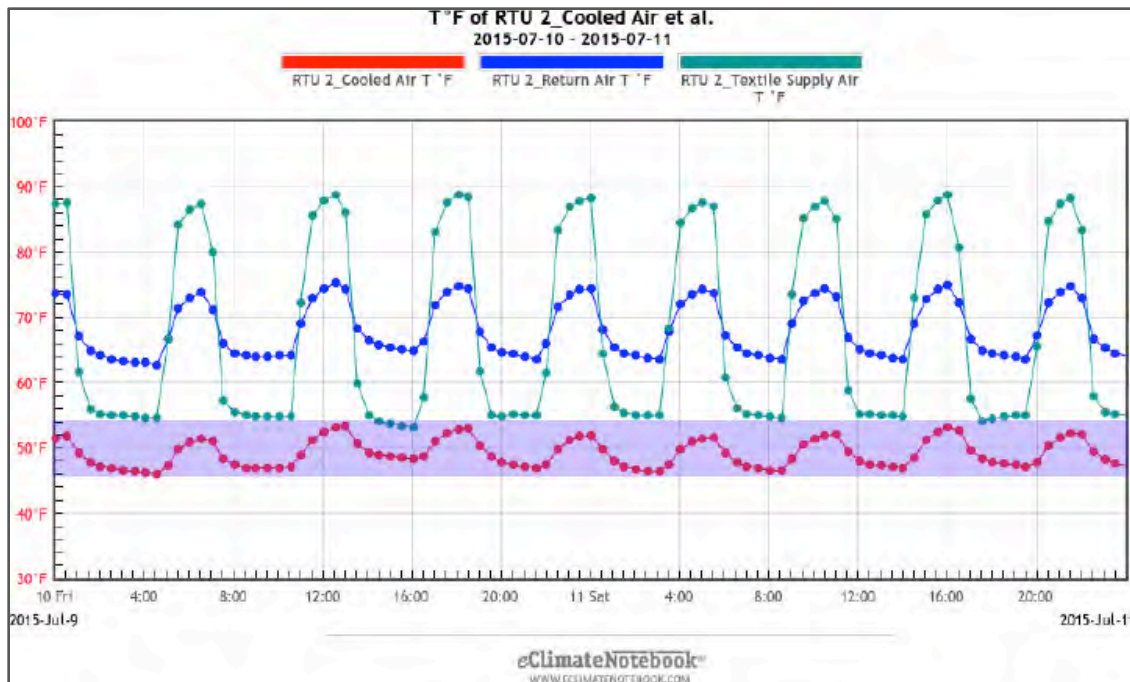
system turns into heating mode all four stages of heating are used. While in heating mode the cooling coil continues to run, however the temperature produced from the heating coil starts to overwhelm the air at the cooling coil. At its peak of operation the unit will keep trying to cool the incoming return air, however the cooling coil can no longer keep up with the return air temperature. Instead of the normal 48°F that the cooling coil produces, the temperature after the coil is around 52°F. The cooling coil has not changed operation and is producing a higher temperature. The heating coil then warms the incoming air to a condition of 88°F. This high supply air temperature causes the return air from the space to jump to around 74°. Including the work lost at the cooling coil there is a total of 62° of sensible energy used in this scenario (22°F of cooling, 36°F of heating, 4°F lost at the cooling coil). While operating in this mode the supply air condition can at times be warmer than the outside air. The following graph illustrates the effect of the heated air on the cooling coil, the fluctuations in return air and the textile space temperatures caused by the cycling over a two day period in July.

In the sub-cool heat scenario, when sensor reaches 65°F the heating coil goes from reheat to heating mode. In reheat mode only one of the four stages of heating are used. When the

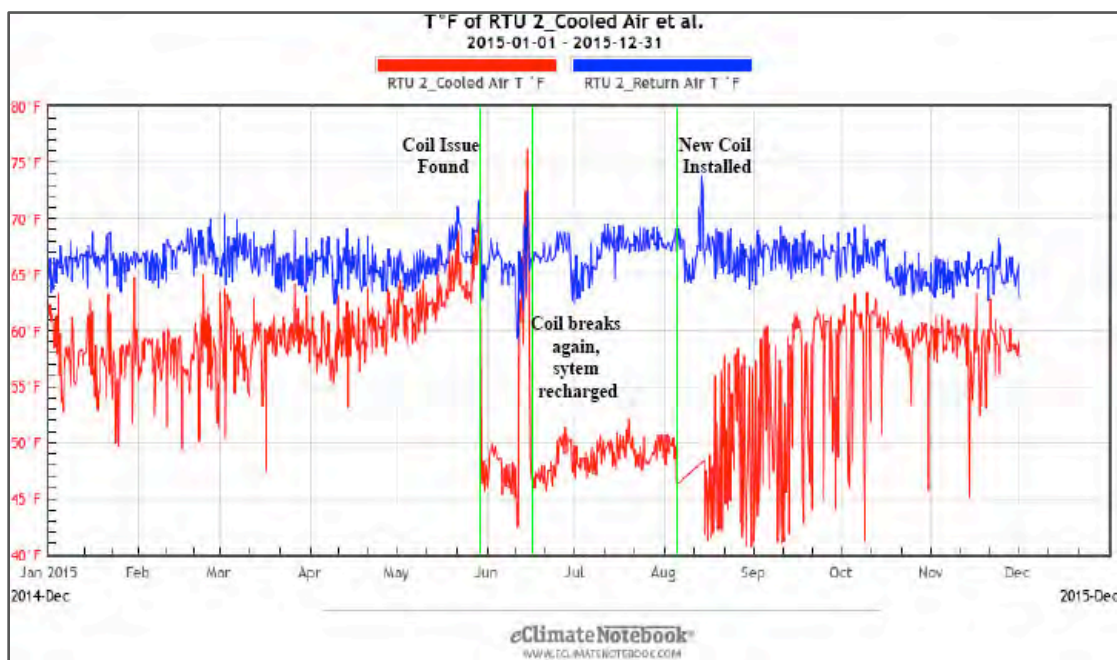
An issue with the cooling coil was discovered on May 29, 2015 when it was discovered that the compressor was leaking. The leak was repaired and a recharge was given to the coil. On June 11 the condition of the unit had worsened. The unit was subsequently shut down and repaired again, including a recharge of the system. A replacement coil and compressor were installed on August 14. After it was recharged in May, the unit was producing a 47°F dew point (DP) which slowly leveled out to 48°-50°F after the second recharge in June. The new coil appears to be able to provide a better DP temperature at around 41°. The unit is unable to hold temperatures near that DP due to the back and forth in the sub-cool reheat and sub-cool heating operation. The graph below illustrates the temperature that is seen at different points during the issue with the cooling coil.

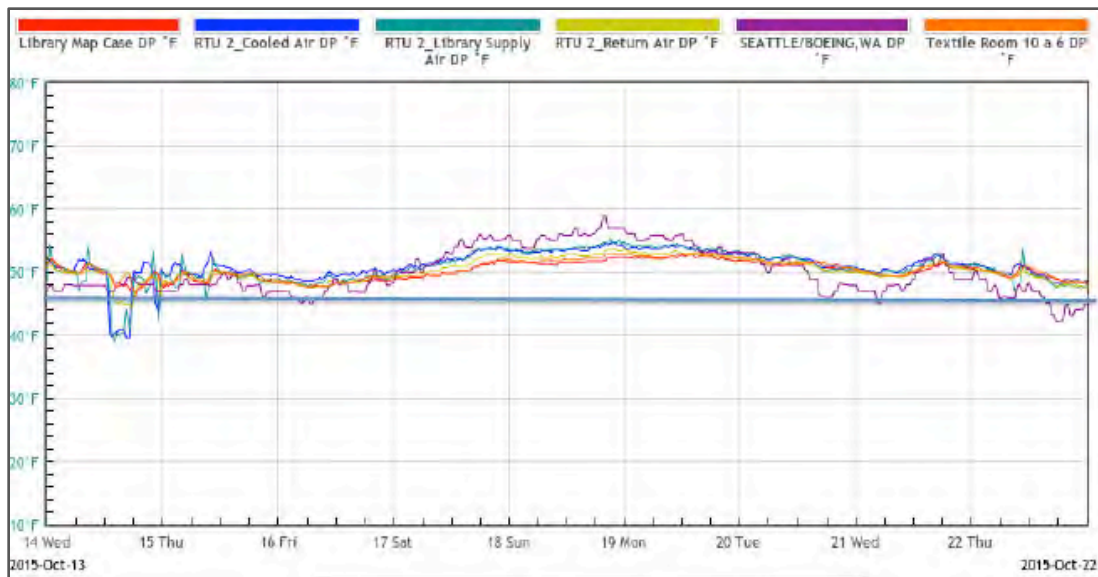
60%, a potentially dangerous situation for collections in these spaces. Based on available data, the system was in sensible heating mode at this time and was not dehumidifying at all. The supply air and cooled air dew points are higher than the dew point in the space. If the cooling coil was operating as needed, the space, cooling coil, and heating coil dew points would be 41-46°F, depending on the new coil's capabilities. The high dew points seen indicate that the cooling coil was not operating as it should. When the DP rises above 48°F, the new cooling coil should open fully and begin to bring the DP down. The switches are visible in eClimateNotebook and on the power consumption graphs as well. The graph below (for October 14 to 22) illustrates the dew point for multiple locations during the October incident.

The system returns to steady sensible cooling mode around September 14, 2015. From October 16 to 21 there was an issue in the unit that caused the RH in the space to rise above

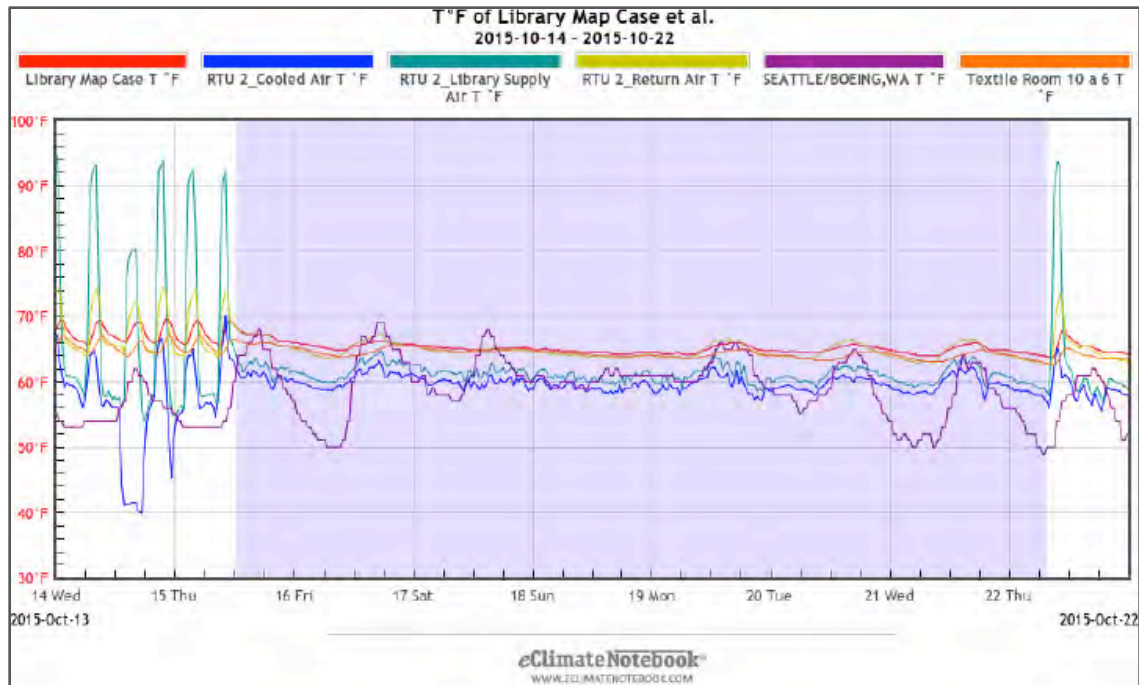
During the same event, while the unit is in sensible cooling mode, the return air entering the unit is around 64-65°F. The air is then cooled to 59-60°F instead of the 41-46°F the unit is capable of. The supply air for the space is around 60-61°F. This information supports the conclusion that very little heating, if any, is added to the supply air. The average outside air temperature at this time was around 60°F and in some instances was higher than the space temperature. The graph below illustrates the temperatures at the time of the October incident.

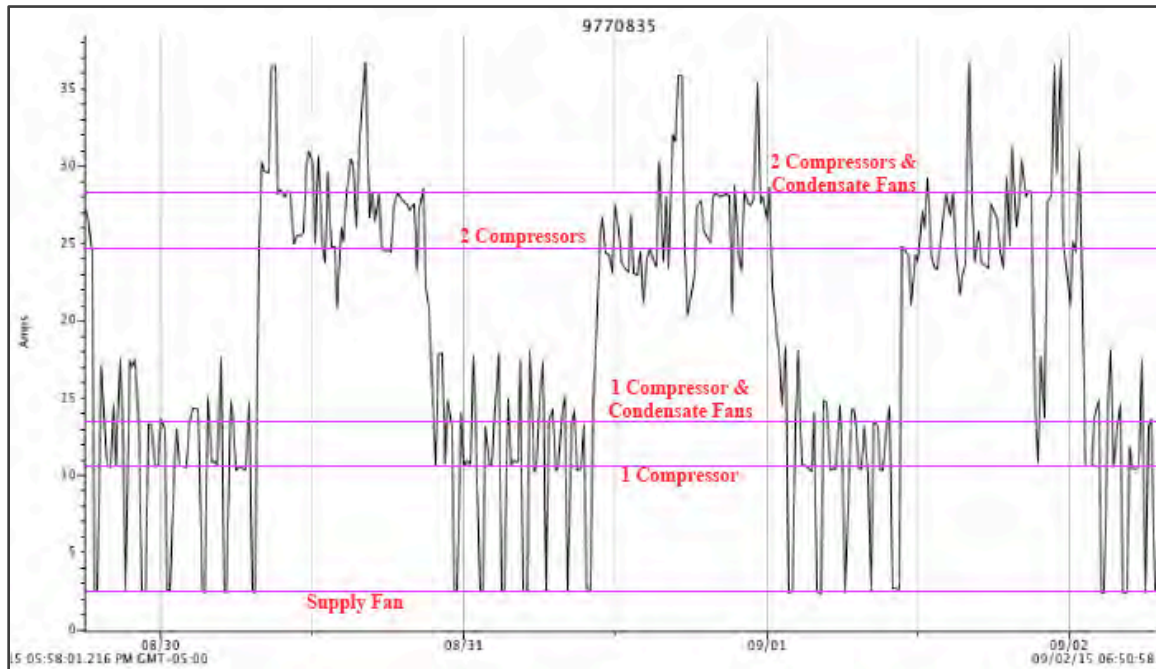
The following graph shows the breakdown of RTU 2's power consumption. All events have been marked on the graph to provide insight into the power consumption and draw of the unit. As you would expect, the unit draws almost twice the energy when running two compressors as opposed to a single compressor. However, the switch from one compressor to two is not happening over months or days as part of a seasonal shift but rather multiple times a day as a side effect from the current system operation. It is also noted that the compressors on the unit run for a total of 18 hours a day.

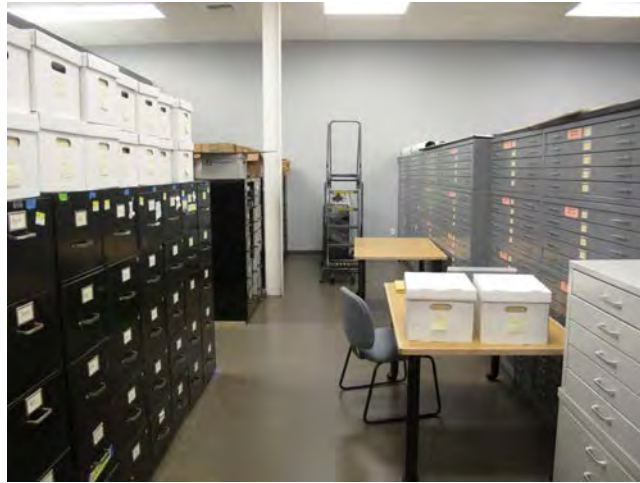
The staff area, which covers almost half of the library space, consists primarily of staff seating with desks, workstations and a conference table. The collection area consists of a row of flat files, a row of filing cabinets, and compact shelving. The compact shelving runs north to south. A section of metal shelving was added along the south wall in 2015.

The collection space is not completely buffered from the rest of the facility. The east wall and half of the north walls in the library are not full walls and terminate nearly a foot from the drop ceiling. The supply and return ducts from RTU 2 are located above the drop ceiling, which appears to use standard acoustic tiles. Air from the other connecting spaces treated by RTU 4 can mix in the open ceiling above the library and could potentially infiltrate the space. This air would be mixed with the space air and unfortunately, due to air return location, be pulled into RTU 2.

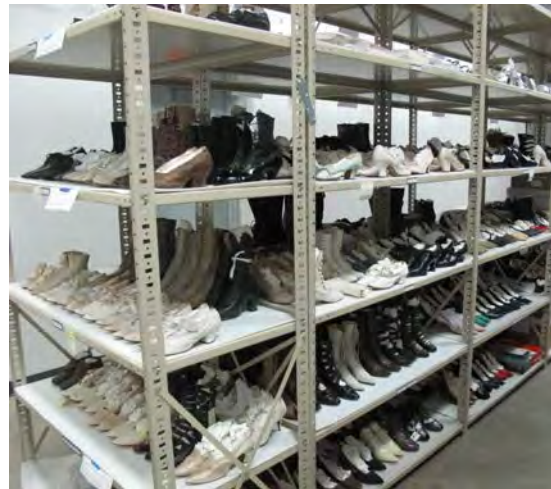
The textile collections are stored in a 3,666 sq. ft. room located on the south side of the facility, adjacent to the library. This space contains a wide variety of collection materials including leather, paper, metal, glass, wood, ivory, celluloid, and rubber. The staff are very concerned that there are materials in this space that are more susceptible to dry conditions than to high moisture conditions. All collections are arranged on shelves, with few to no materials on the floor or in the work area. There are hanging textiles in the shelving area, grouped with other textiles, and these shelves are covered with muslin. Some items such as shoes are kept in the open while all other items are stored in boxes.

The envelope for the space is very basic. The walls are drywall with a base coat of white paint. The top half of the exterior walls are covered with an insulation barrier that is mounted directly to the block wall. The floor is unpainted or sealed concrete. The edges of the floor along the exterior wall had temperatures 20-25°F colder than the rest of the room. The floor temperature in this area should be inspected in the summer to watch for the possibility of condensation.

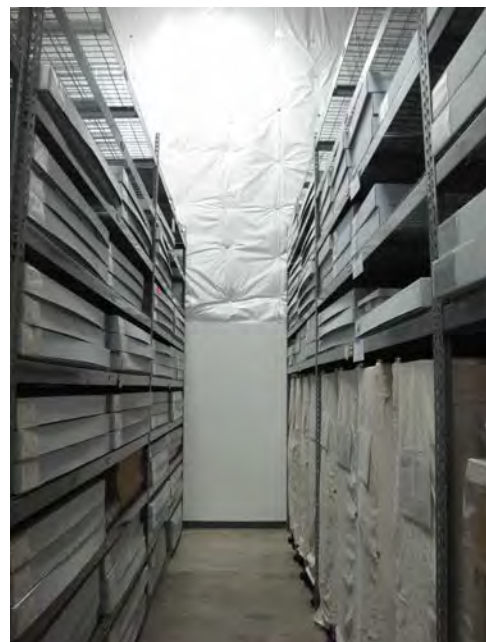
There is no drop ceiling in the space; the underside of the roof is visible from inside, nearly twenty feet from the ground. The textile room is equipped with 15 four-bulb T8 light fixtures, controlled by a main switch near the entry door. The space is equipped with emergency lighting designed to stay on at all times. The emergency lighting consists of two or three fixtures that are connected to other light fixtures. These fixtures do not generate an excessive amount of light or heat in the space.

All air that conditions this space is supplied by RTU 2. The 24-inch main supply duct enters the space through the north wall. This duct then splits into two 18-inch ducts with one half supplying air to the east half of the space and the other serving the west half of the space. The diffusers are located nearly eight feet over the shelving and distribute air into nearly every other row of shelving. There is no ducted return within the space. Air from the space is returned to the system through a passive vent on the north wall that connects to the library space. There are no other returns located within the space.

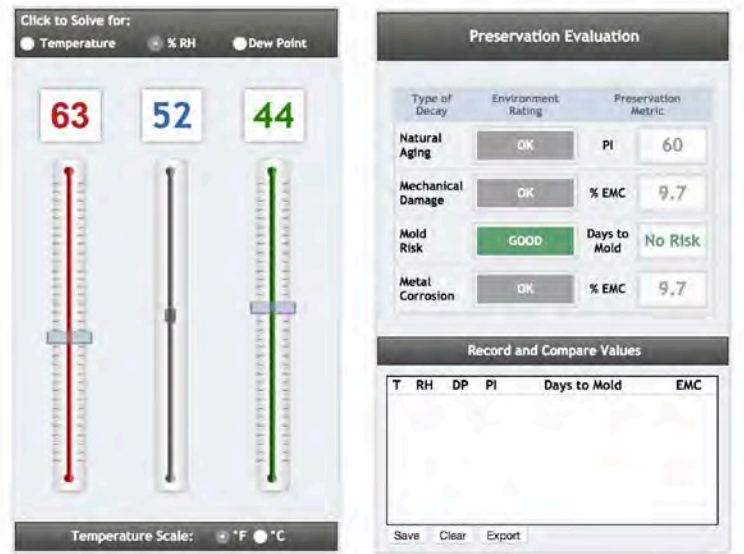
With a new space layout the system set points could be lowered a few degrees in the storage spaces to provide a slightly better storage condition. A setting of 63°F/52%RH/44°DP would yield a better PI and the overall metrics would remain satisfactory. The lower temperature will require less reheat from the unit and should result in some cost saving over the season. With the staff area on its own unit or with its own reheat, human comfort is achieved while improving the preservation quality of the collection.

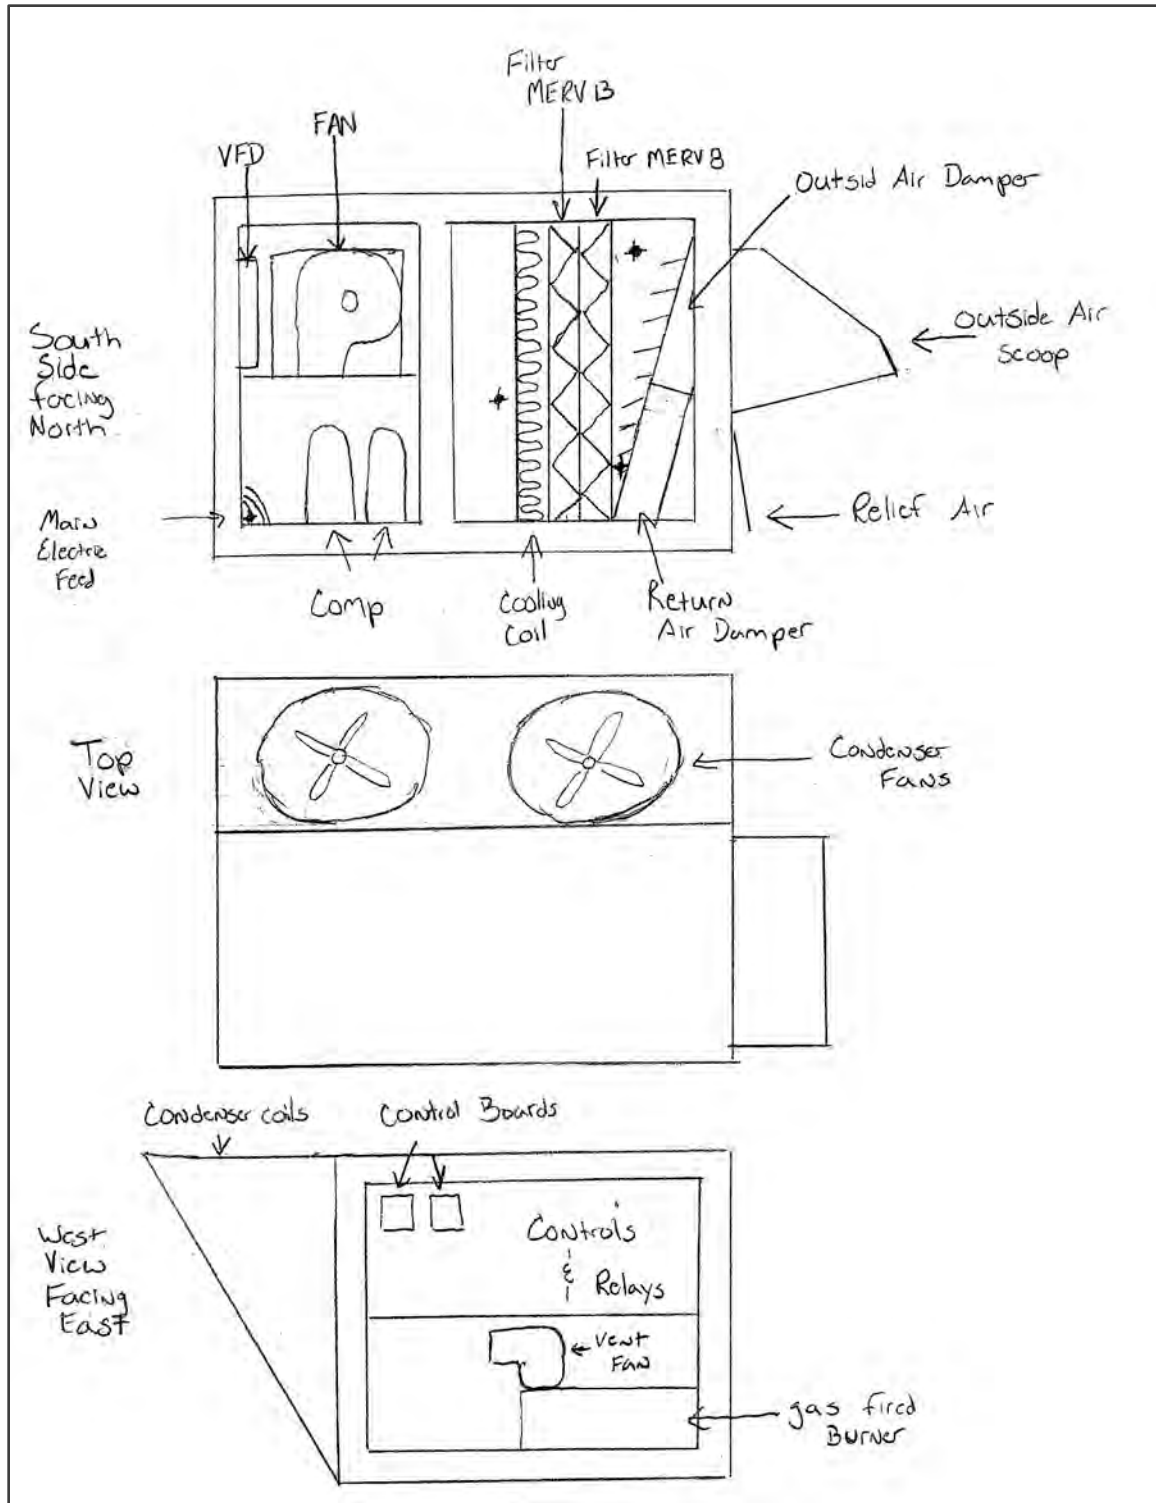
Appendix A: Diagram of Rooftop Unit (RTU) 2

The unit that conditions the library and textile space is RTU 2, a fifteen-ton standard DX rooftop unit. In this system, the return air and supply air meet in a mixed air chamber, and the mixed air is first pulled across the filter medium and then across the cooling coil. Next, the air moves through the supply fan where it is pushed across the heating coil and then distributed to the collection spaces. (See Appendix A for a diagram of the system layout.) RTU 2 is located on the roof of the Center, directly above the library staff area. As air travels through the ductwork the first distribution point is the library staff area, which means that this space gets the primary push of air out of the unit. The main duct line then splits in two, sending a majority of the air into the textile area and the remainder to the library shelving area.
